Foot Screening Mapping Examples

Foot Screening Mapping Examples Touch-Test™ Sensory Evaluators

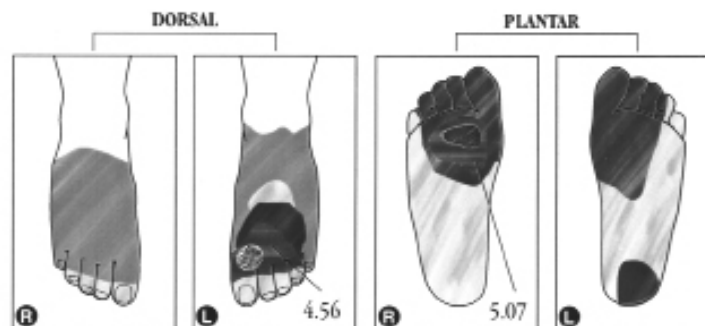
Initial Evaluation - Visit #1

RIGHT FOOT: Superficial ulcer on plantar surface over the second metatarsal head.

LEFT FOOT: Pre-ulcer proximal to the first dorsal web space.

Patient education, treatment intervention and wound care management initiated.

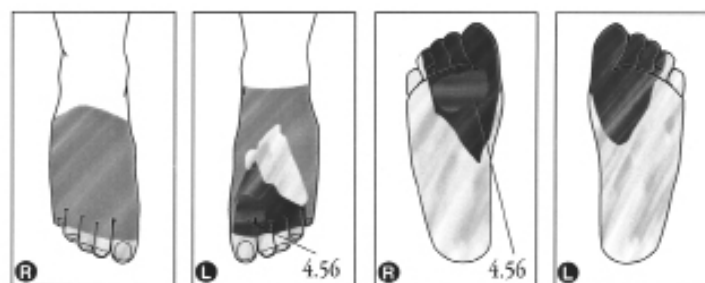
Re-evaluation - Visit #2

RIGHT FOOT: Ulcer healed. Improved to diminished protective sensation on plantar surface over the second metatarsal head.

LEFT FOOT: Pre-ulcer healed. Loss of protective sensation proximal to the first dorsal web space.

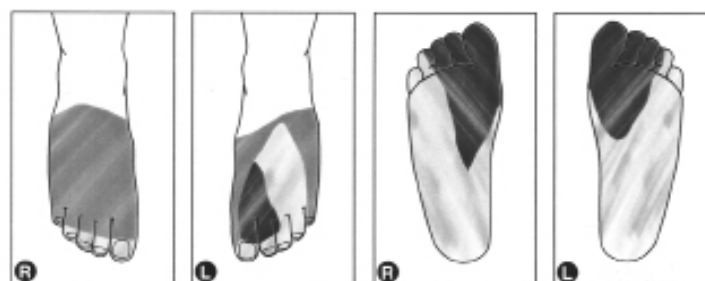
Re-evaluation - Visit #3

BOTH FEET: Diminished light touch sensation at toes and plantar surfaces.

LEFT FOOT: Improved to diminished protective sensation proximal to the first dorsal web space.

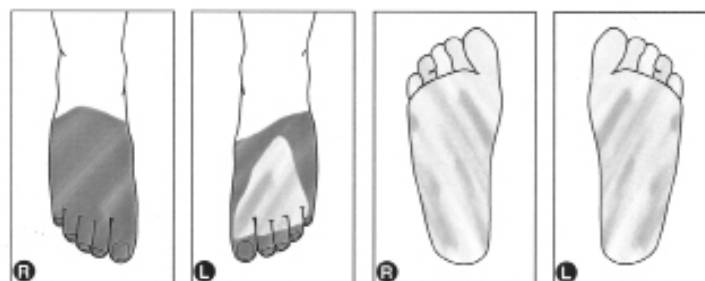
Re-evaluation - Visit #4

RIGHT FOOT: Normal throughout.

LEFT FOOT: Improved to diminished light touch sensation over dorsal web spaces.
